**2308 Edgemont Way
Anderson IN 46011**

**BPO PHOTO
ADDENDUM**

Case #: Today's Date: 02/09/2016
 Full Address: 2308 Edgemont Way Anderson IN 46011
 Inspector/Appraiser: Regina Nottingham Reason taken: Add. interior BPO

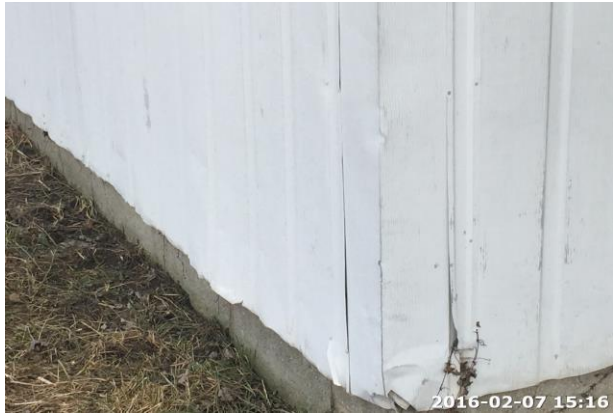
<p>2016-02-07 15:16</p> <p>Siding is in sad shape</p>

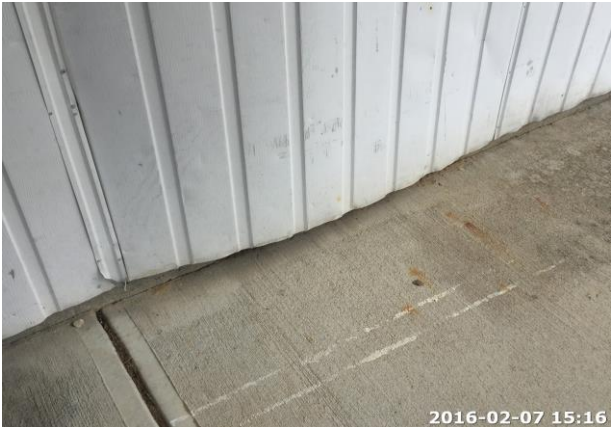
<p>2016-02-07 15:16</p> <p>Siding is in sad shape</p>

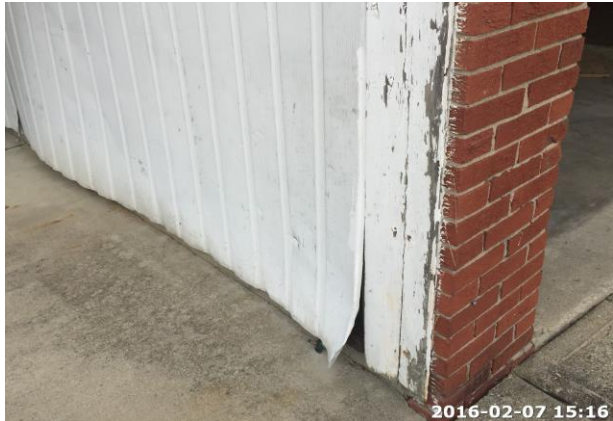
<p>2016-02-07 15:16</p> <p>Siding is in sad shape</p>

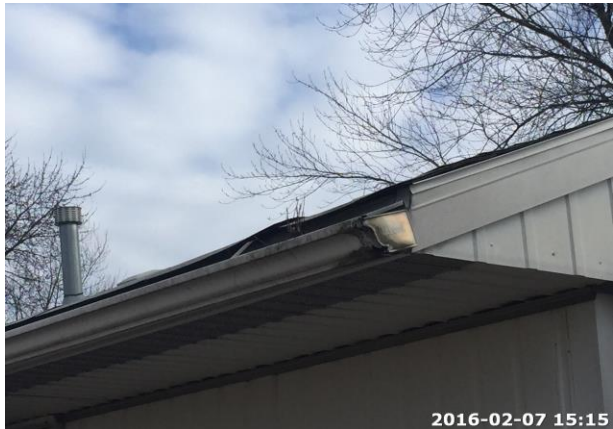
<p>2016-02-07 15:15</p> <p>Gutter issues</p>

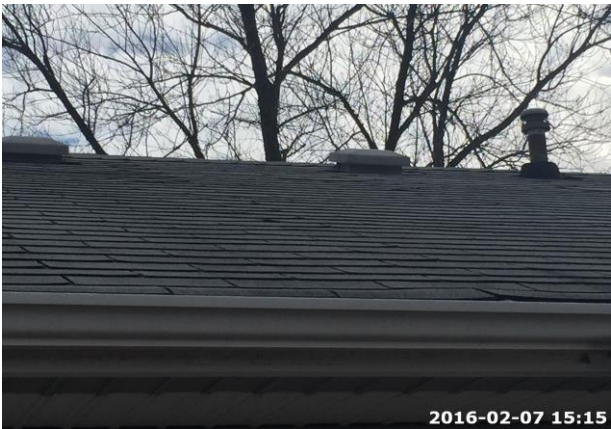
<p>2016-02-07 15:15</p> <p>Roof is very old</p>

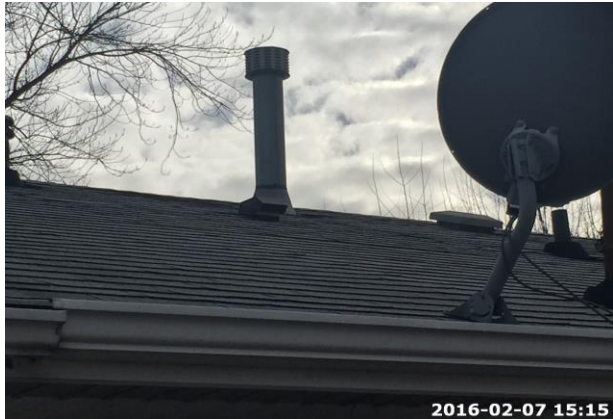
<p>2016-02-07 15:15</p> <p>Roof is very old</p>

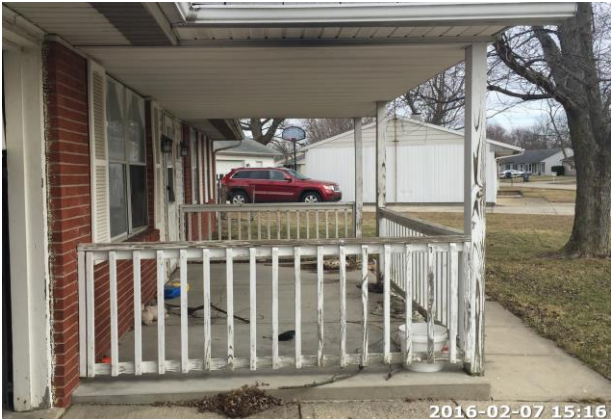
<p>2016-02-07 15:16</p> <p>Exterior trim need attention</p>

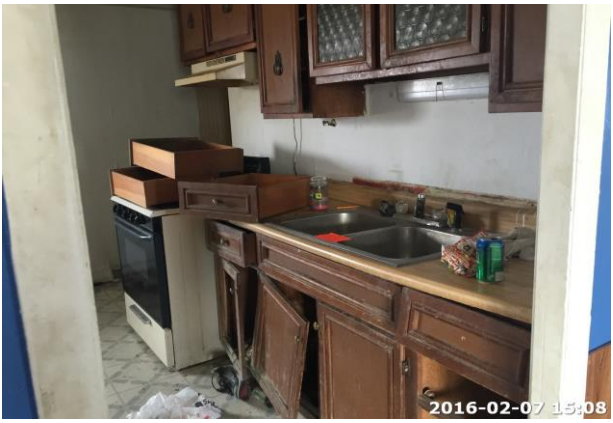
<p>2016-02-07 15:08</p> <p>Kitchen cabinets are in disrepair and not salvageable.</p>

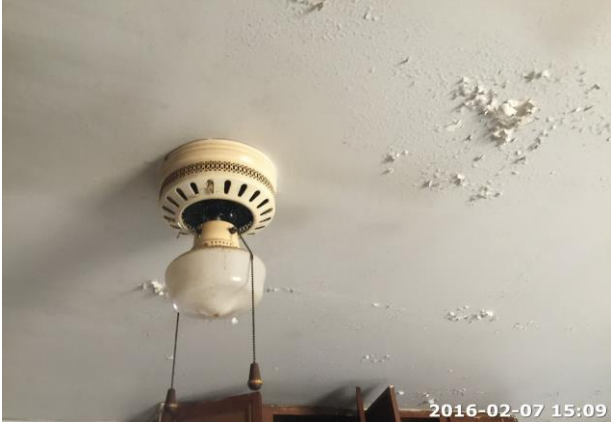
<p>2016-02-07 15:09</p> <p>Fixtures and possible lead paint</p>

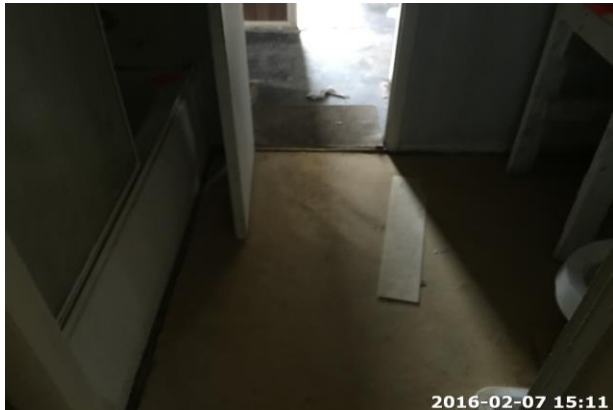
<p>2016-02-07 15:11</p> <p>No flooring</p>

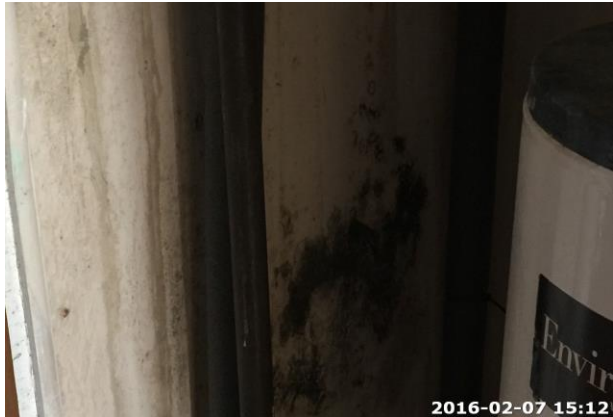
<p>2016-02-07 15:12</p> <p>Mold-like growth</p>

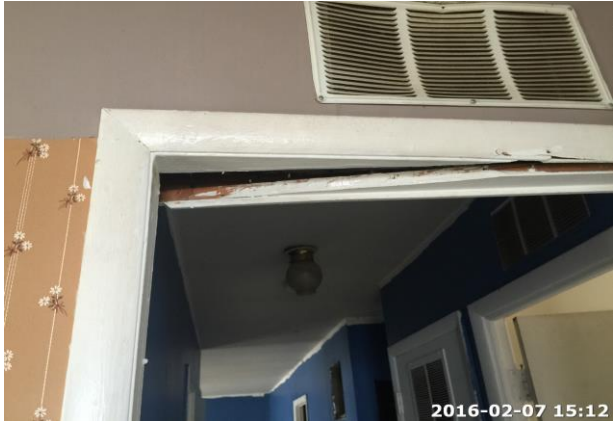
<p>2016-02-07 15:12</p> <p>Missing some interior doors, broken interior doors, example of carpentry work needed.</p>

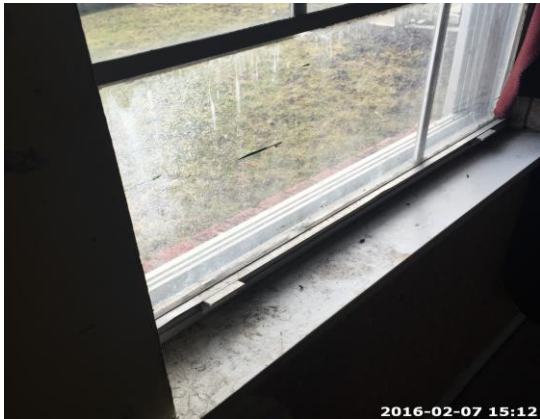
<p>2016-02-07 15:12</p> <p>Old metal windows, mold-like growth</p>

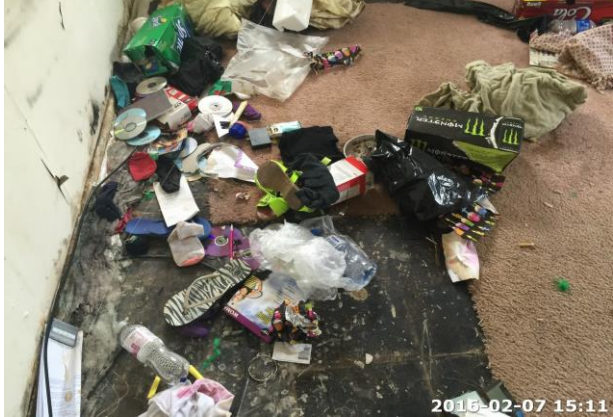
<p>2016-02-07 15:11</p> <p>Debris, flooring, mold-like growth</p>

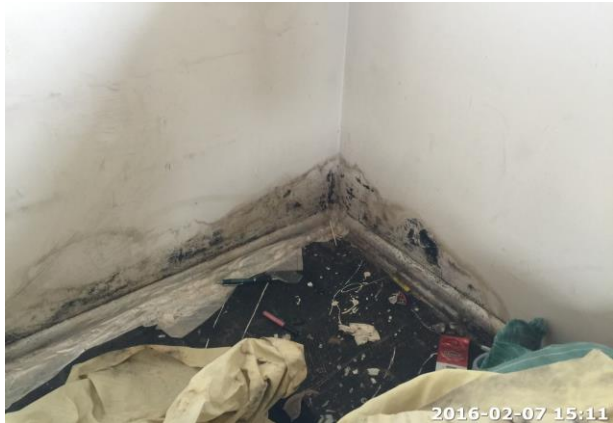
<p>2016-02-07 15:11</p> <p>Mold-like growth</p>

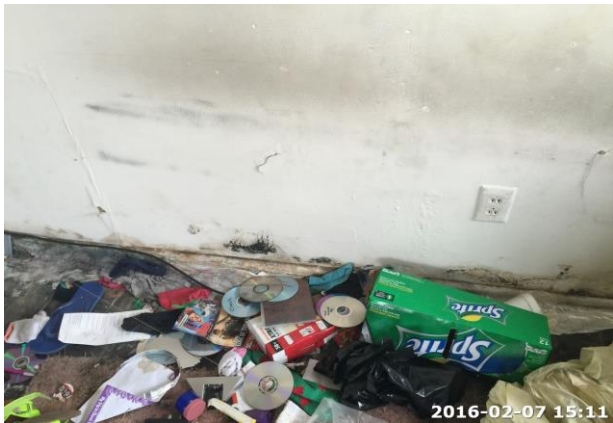
<p>2016-02-07 15:11</p> <p>Mold-like growth</p>

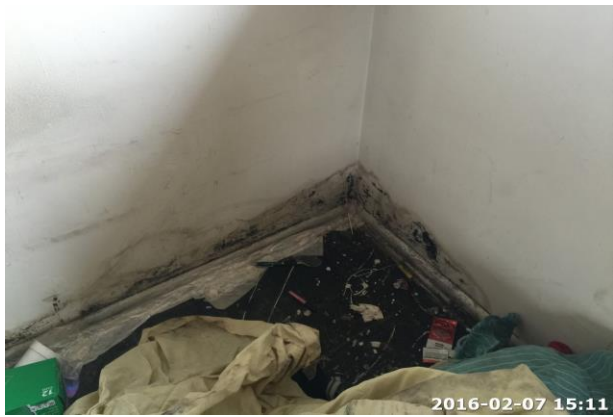
<p>2016-02-07 15:11</p> <p>Mold-like growth</p>
