Broker/Agent Estimate

| | Subject Property | Sold Comparables | | | | Listed Comparables | | |
|---|---|---|--|---|--|---|---|---|
| Street Address | 705 Frebis Ave # 707 Columbus, OH 43206 | 638 Hanford St Columbus, OH 43206 | 1167 Linwood Ave Columbus, OH 43206 | 519 E Welch Ave Columbus, OH 43207 | | 1802 Bucher St Columbus, OH 43207 | 48 East Gates Street Columbus, OH 43206 | 141 E Woodrow Ave Columbus, OH 43207 |

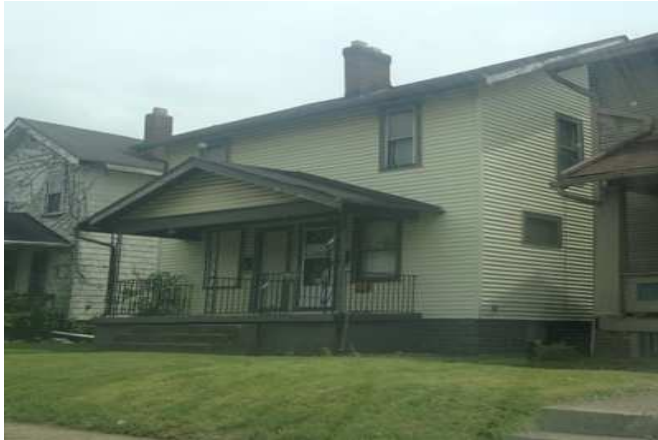
Subject Front View

| Subject appears to be in fair condition for the neighborhood. One of the units does appear to be occupied. |

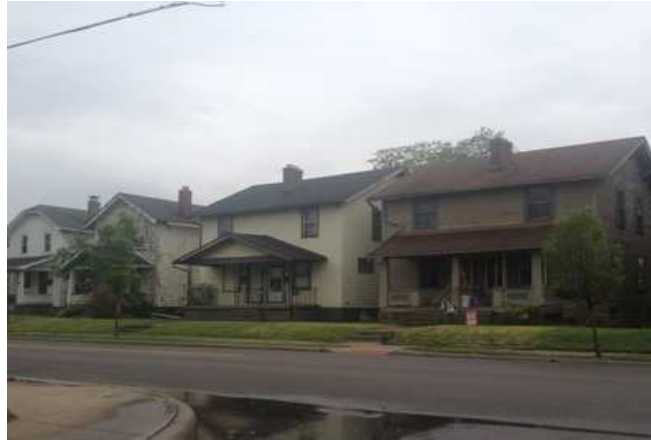
Subject Left Profile

Very difficult to get left side of the property due to heavy traffic and no stopping along the curb sides.

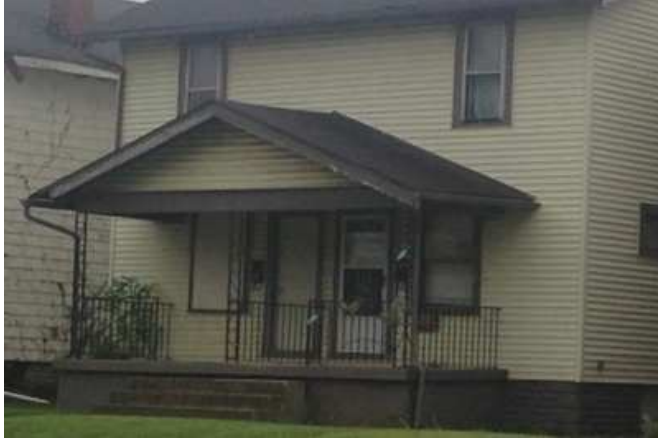
| Boarded Home | Yes |

Repair: Boarded up window

| <input checked="" type="checkbox"/> Boarded up window | \$ 250 | | |
