Broker/Agent Estimate

| | Subject Property | Sold Comparables | | | | Listed Comparables | | |
|---|---|---|--|---|--|---|---|---|
| Street Address | 705 Frebis Ave # 707 Columbus, OH 43206 | 638 Hanford St Columbus, OH 43206 | 1167 Linwood Ave Columbus, OH 43206 | 519 E Welch Ave Columbus, OH 43207 | | 1802 Bucher St Columbus, OH 43207 | 48 East Gates Street Columbus, OH 43206 | 141 E Woodrow Ave Columbus, OH 43207 |

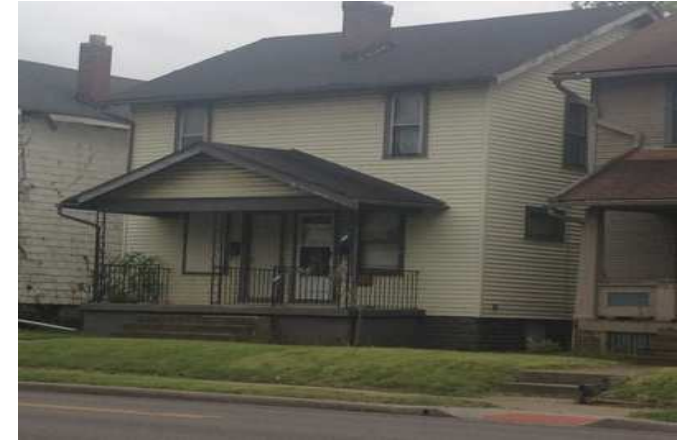
Subject Right Profile

Very difficult to get left side of the property due to heavy traffic and no stopping along the curb sides.

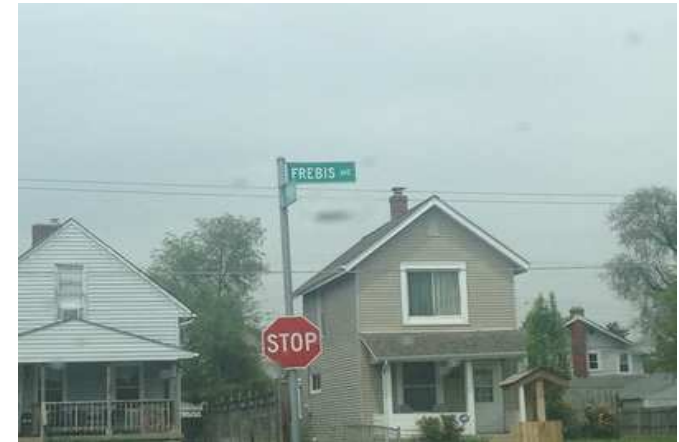
Subject Address

Frebis Avenue has no street parking. Very busy road unable to stop long enough in front to take house number picture.
